Summit-Martin Fires

Summit Fire CASCU002548

Martin Fire CACZU005238

State Emergency Assessment Team (SEAT)
Report

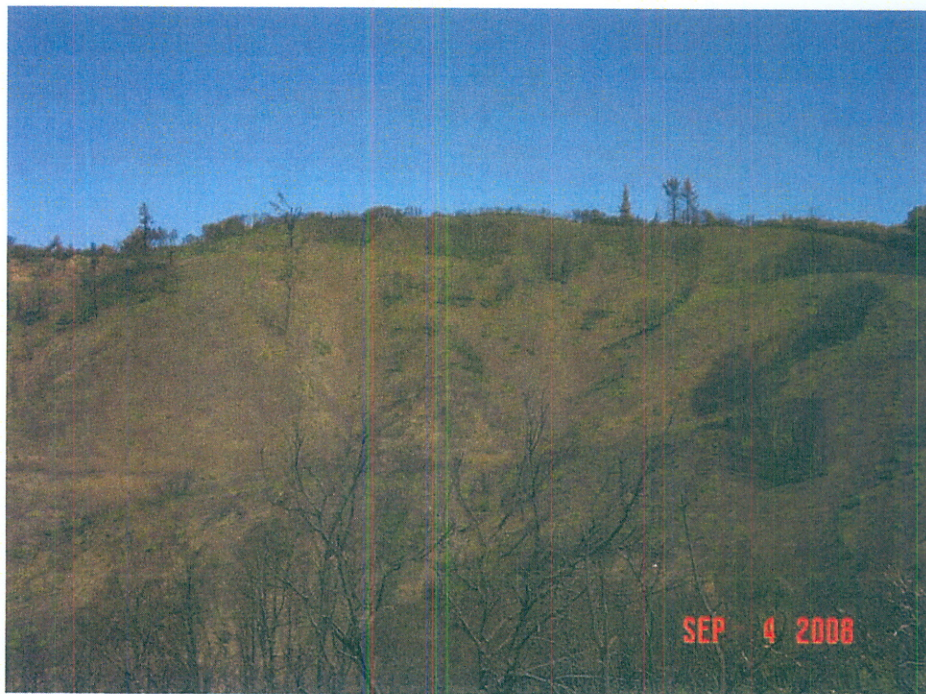
Figure 1-Looking at south hillside from Maymens Road.

The type of burn severity at the Summit Fire ranges from low to high. Of the 4,189 acres that burned; 18% has high, 37% has moderate and 38% has low burn severity. Remaining areas are not burnt. Major gulches, as described in the setting section above, typically have low to moderate burn severities. Many of the ridges and their hillsides have moderate to high burn severities. The upper watershed between Ormsby Cutoff Road and the north end burn perimeter along with the areas adjacent to the southwest of Ormsby Cutoff Road has the largest extent of high burn severity. These areas drain into Corralitos and Soquel creeks. Though these soils are completely exposed, new vegetative growth was witnessed during the field surveys. This new growth was common in high burn severity areas and is seen below in Figure 1. Most of the Santa Clara County side of the fire has low to moderate burn severities, though high burn severity exists in some areas that drain into Swanson and Alec canyons.
